ASIA TURBOMACHINERY & PUMP SYMPOSIUM
SINGAPORE | 22 - 25 FEBRUARY 2016
M A R I N A B A Y S A N D S

Measurements and Analysis of High Machine Vibration: A Case Study of Screw Compressor Rub

Sherif Mekawey
Principal MDS Leader
GE M&C Bently Nevada

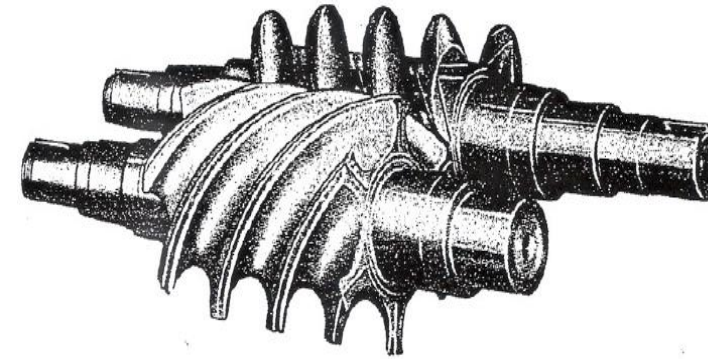
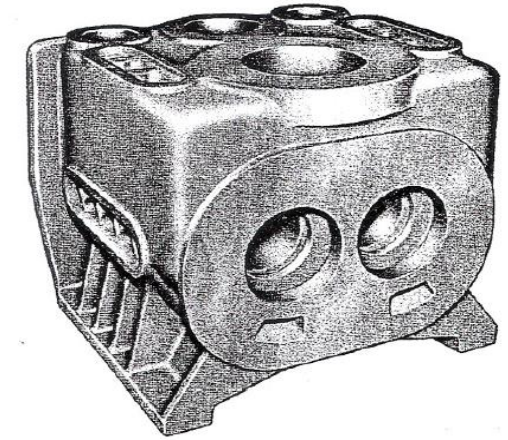
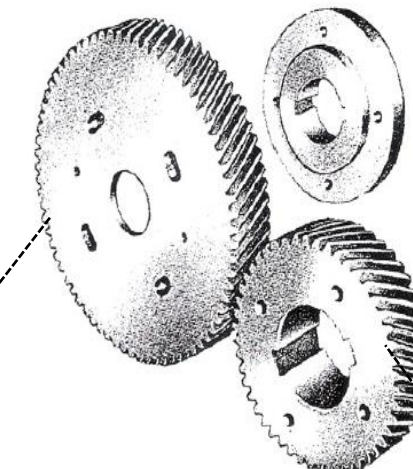
Female timing gear: 114

Male timing gear: 76

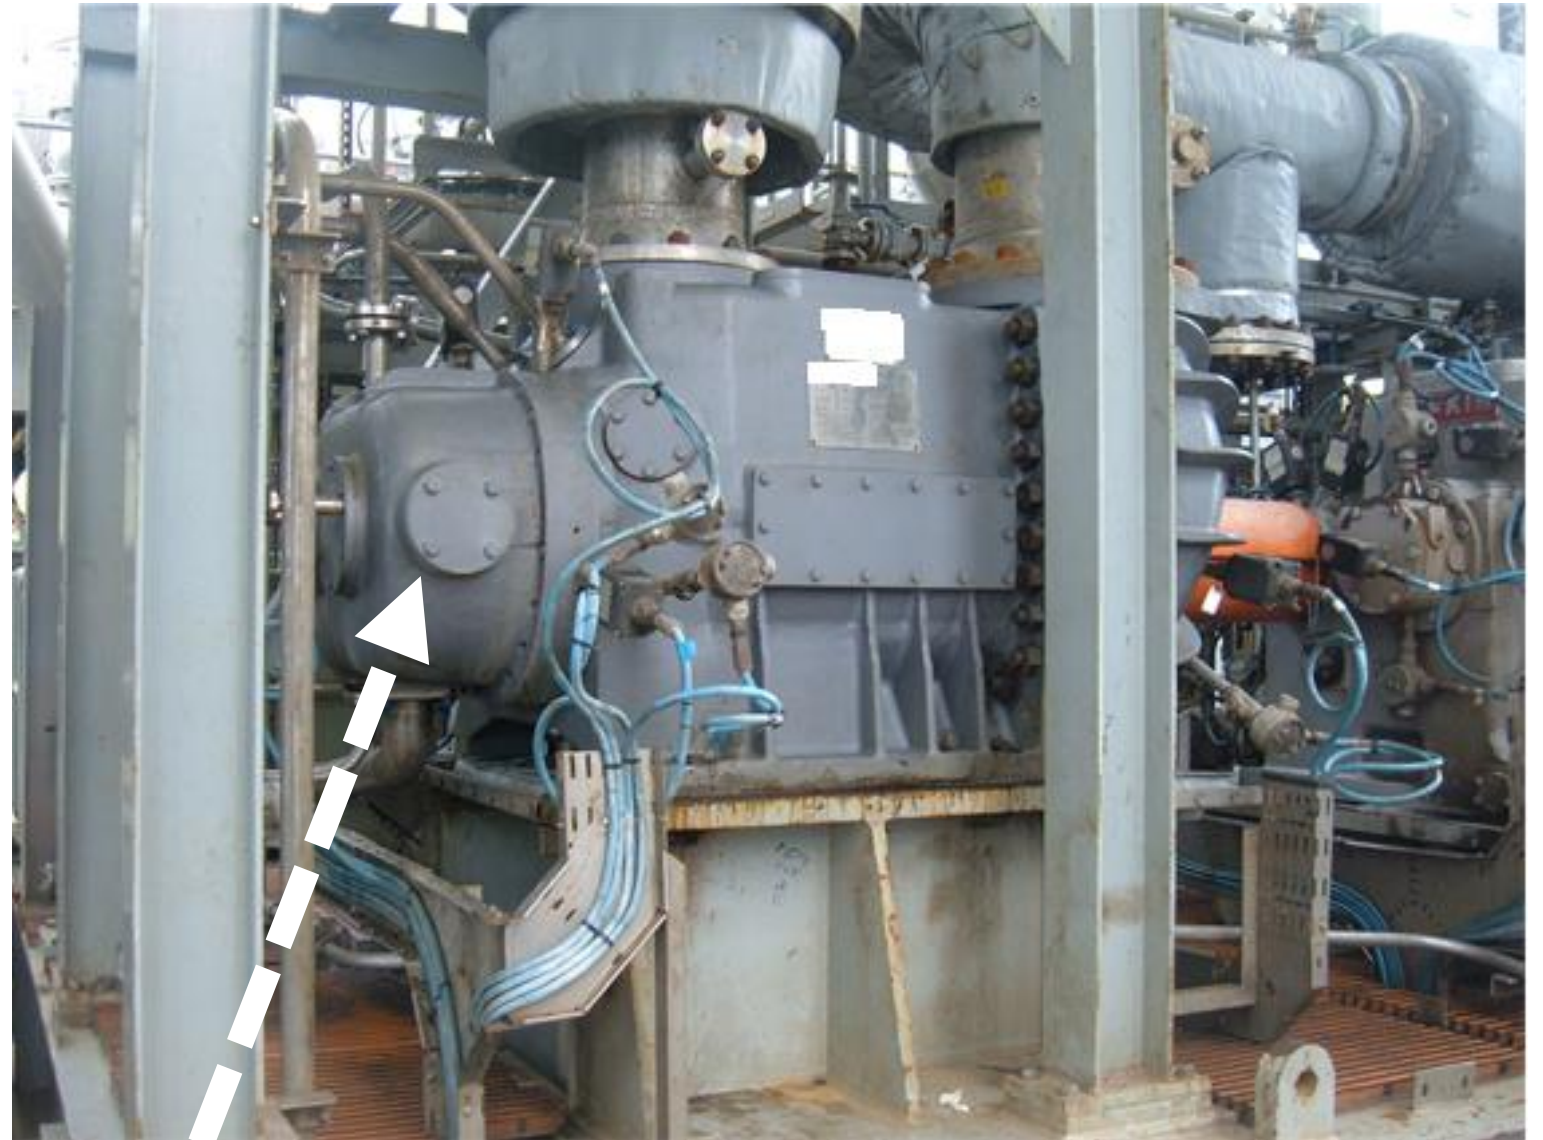
Compressor free end

Proximity probe
installed on compressor
suction end

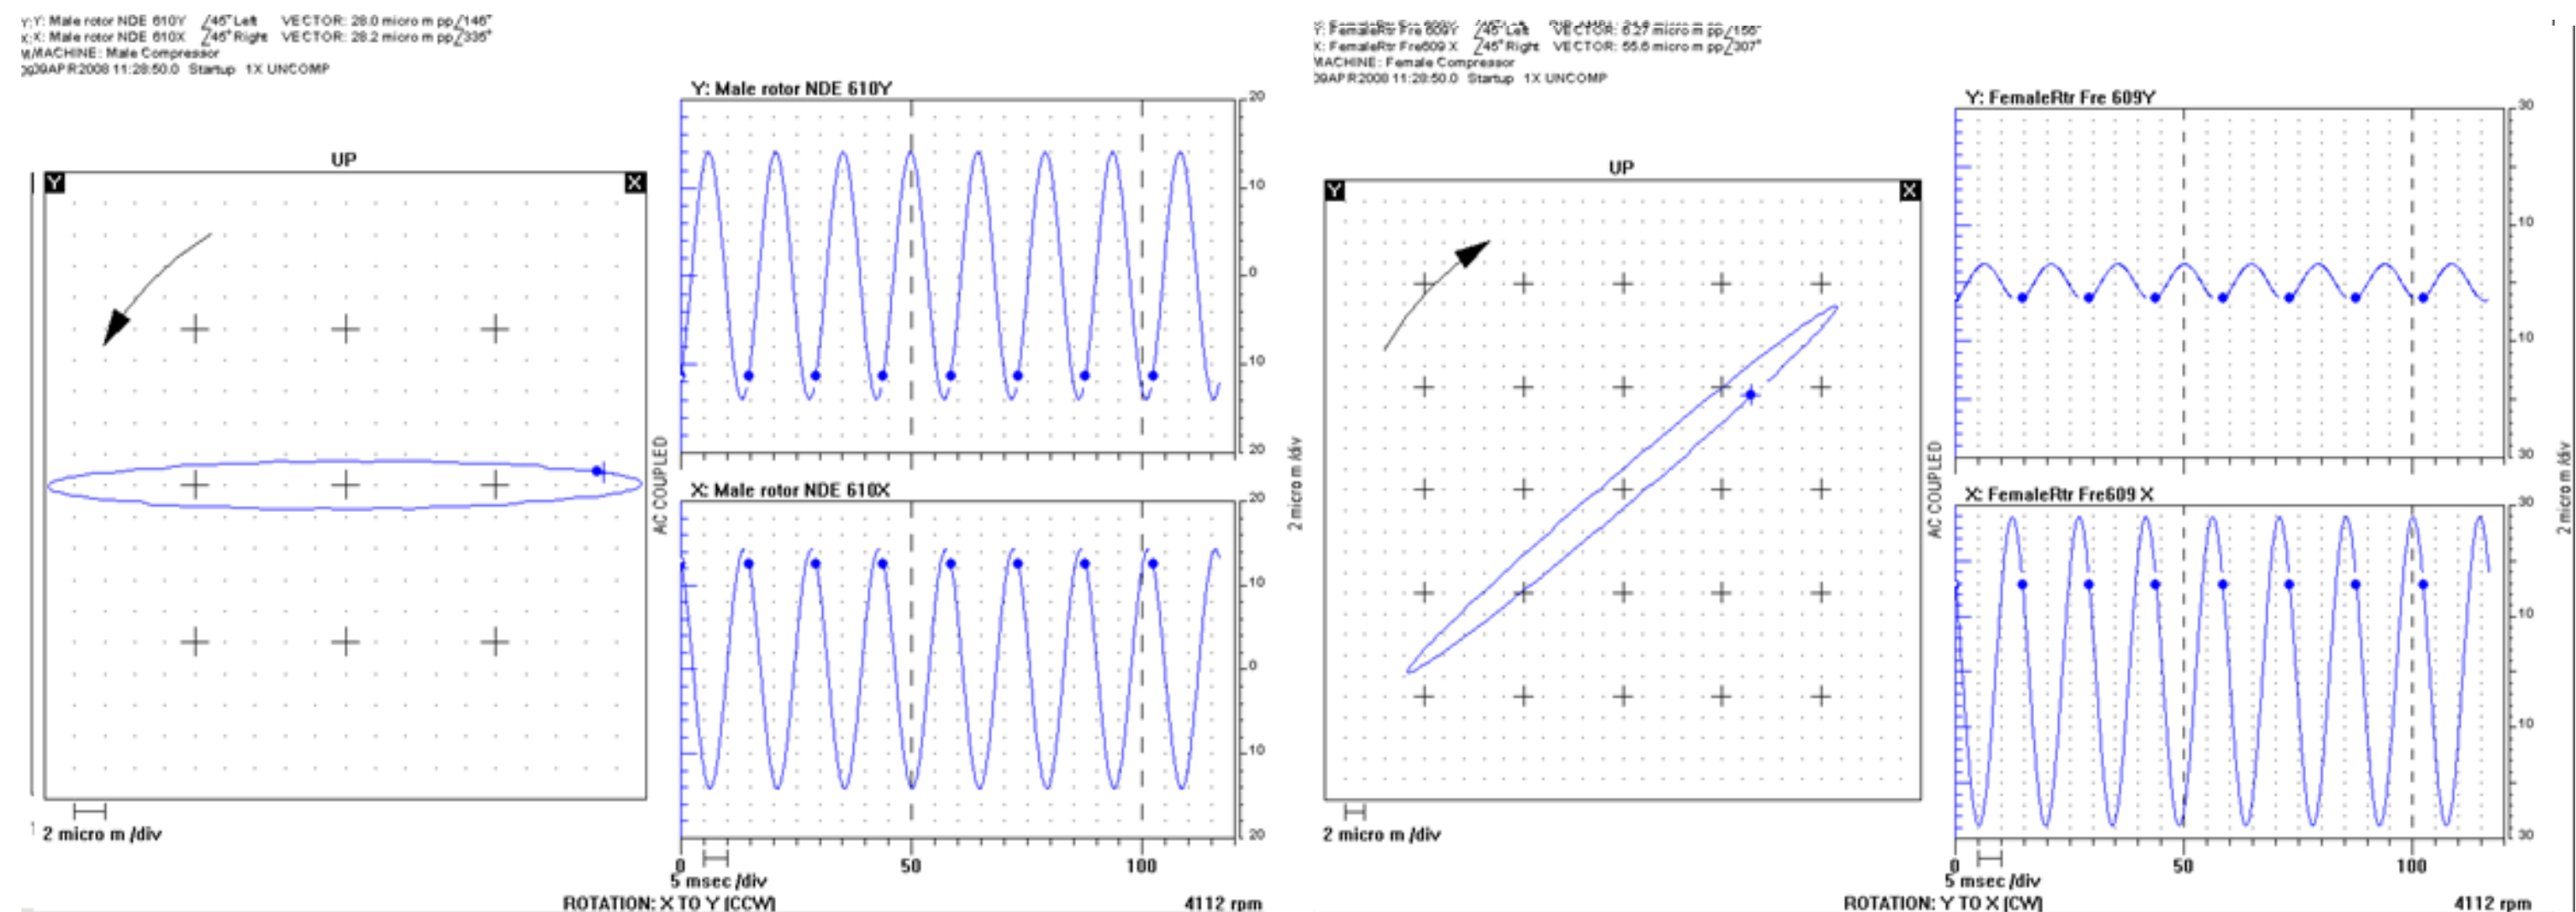
Compressor Startup Data After Seals Replacement

Unusual Direct orbits and elliptical 1X - filtered orbits of male and female free ends at same speed

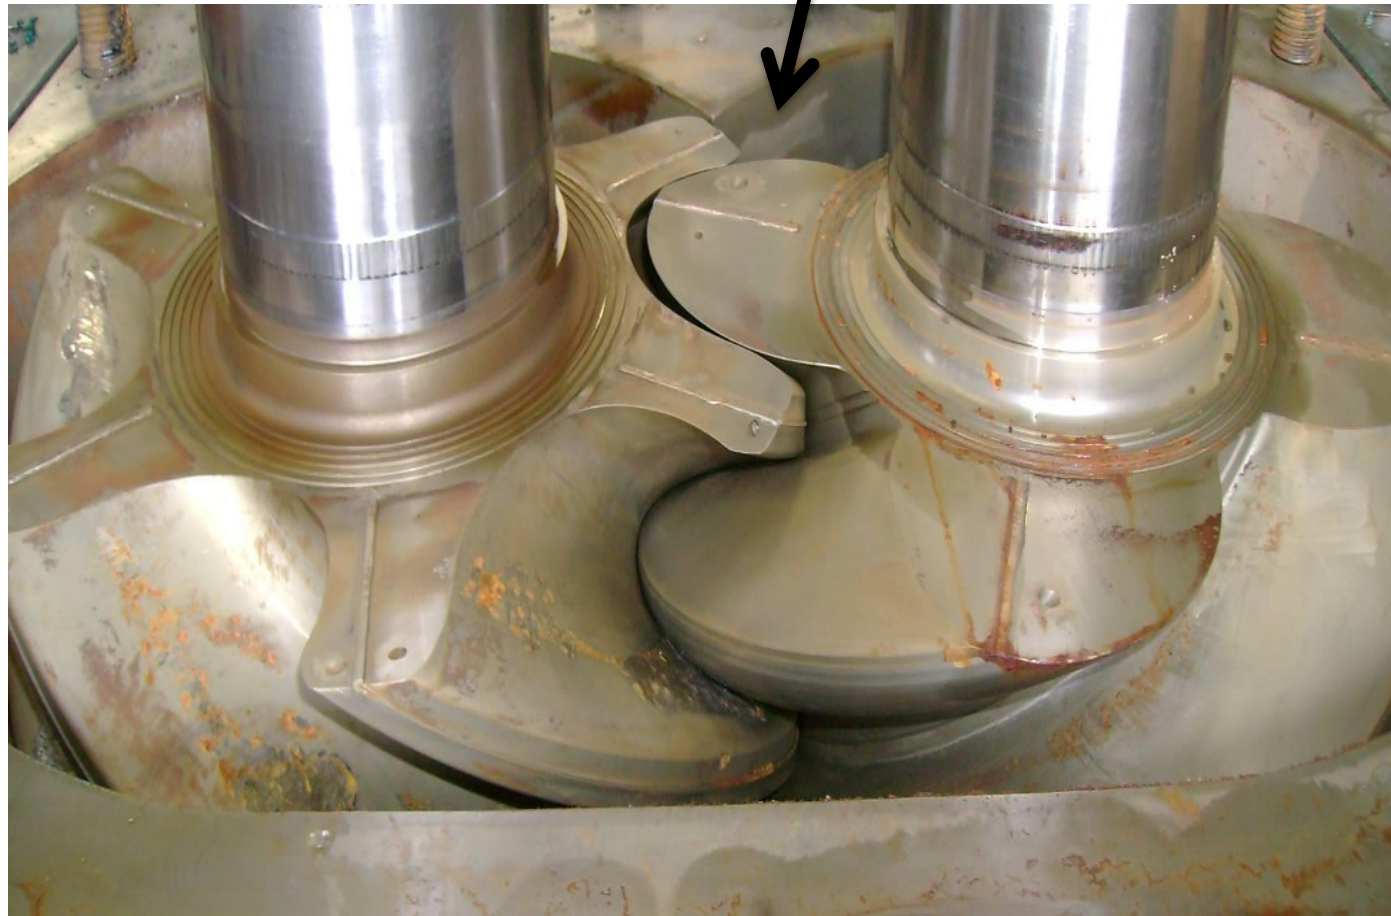
Minor damage to Rotor housing

View following removal of
suction end casing

- The conditions of the timing gears were found satisfactory during inspection, they were reused and set up correctly
- The blocked and corroded splitter in discharge end cover was replaced
- Male and female rotors were cleaned and dressed
- Runout check confirmed slight out of roundness of male rotor and it was polished
- Trim balancing was performed at low speed
- End-user contacted seal supplier to discuss permanent fix to the problem of frequent seals contamination
- Compressor started successfully and overall vibration of male and female rotors' free end reduced considerably to 21 μ m pp and 17 μ m pp respectively during steady state operation after the correctional changes.
